Mr. Jeff Price  
Manager of Quality & Safety Compliance  
Shakespeare Composite Structures  
19845 U.S. Highway 76  
Newberry, SC 29108

SUBJ: RCRA Compliance Evaluation Inspection  
Shakespeare Composite Structures (Shakespeare)  
EPA ID No.: SCD 006 540 983

## RCRA Compliance Inspection Report

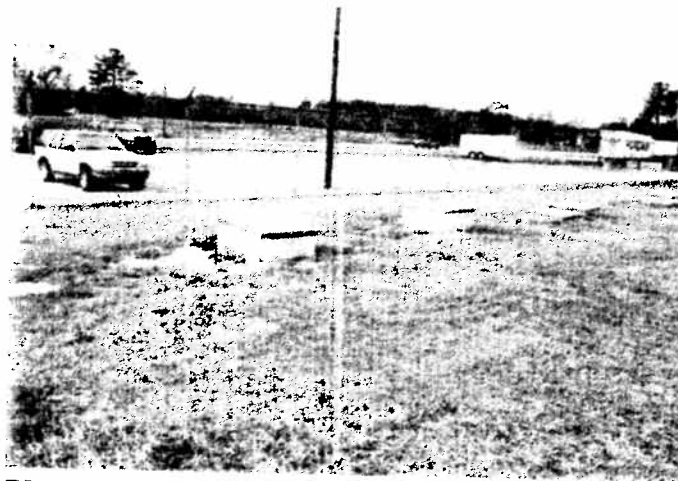
**Photo 4. "Septic system" at Shakespeare.**

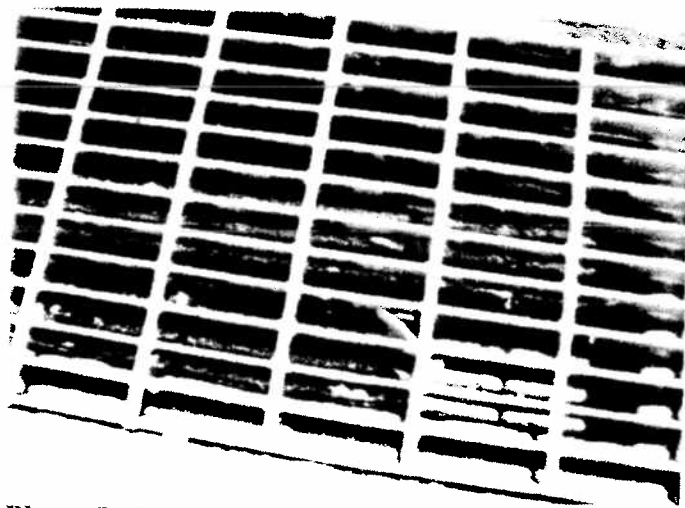
At the time of inspection, the drain at the entrance to this room contained a brown liquid mixed with powder-like materials (Photo 5). Since this drain leads outside of the building to a "septic system," and the facility failed to clean up the spilled materials and make an adequate waste determination, the facility has failed to maintain the facility prevent a potential release of hazardous waste constituents to the environment.

**Shakespeare has failed to adhere to a condition for exemption from RCRA § 3005 given in SCHWMR R.61-79.265.31 [40 CFR § 265.31], as incorporated by SCHWMR R.61-79.262.34(a)(4) [40 CFR §262.34(a)(4)]. This regulation requires that facilities be maintained and operated to minimize the possibility of a fire, explosion, or any unplanned sudden or non-sudden release of hazardous waste or hazardous waste constituents to air, soil, or surface water which could threaten human health or the environment. As such, Shakespeare is storing hazardous waste, without a permit or interim status, in violation of RCRA § 3005.**

**Photo 5.** Drain at entrance of Resin Mix Room.

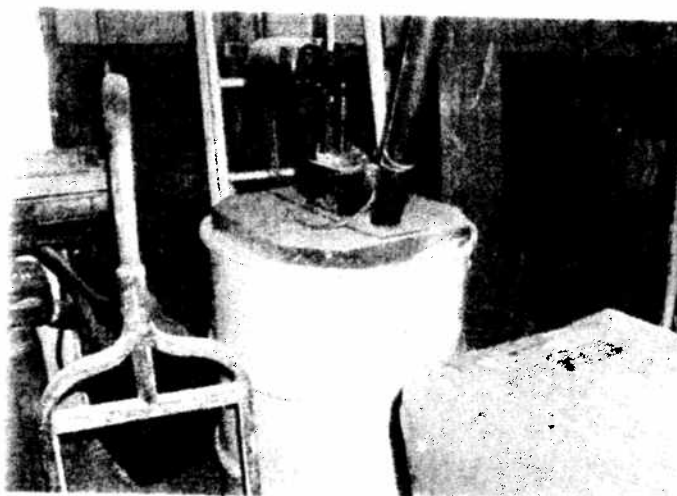
This portion of the facility is where Shakespeare has their "bulb crusher" used to grind used lamps. The crusher consists of an electrical crushing unit attached to a 55-gallon drum (Photo 6). The facility had not performed a hazardous waste determination on the crushed bulbs and was sending the crushed material off-site as a non-regulated waste.

**Shakespeare is in violation of SCHWMR R.61-79.262.11 [40 CFR § 262.11]. This regulation requires that a person who generates a solid waste, as defined in SCHWMR R.61-79.261.2 [40 CFR § 261.2], must determine if that waste is a hazardous waste using the methods described in this section.**

**Photo 6.** Bulb crusher in Maintenance Area.

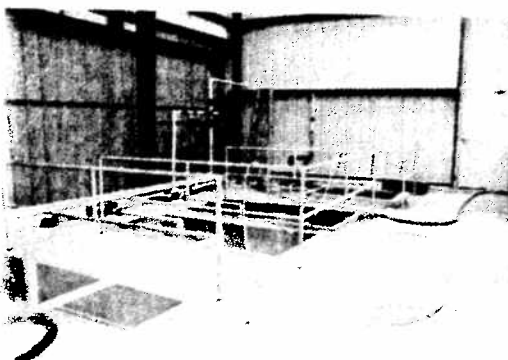
Shakespeare's wastewater treatment system is located in a separate building behind the Main Operations Building. The wastewater treatment system in this building was revamped in May 2003 when Genlyte Thomas acquired the company. Currently, wastewater from cooling and grinding operations is collected in four concrete basins (Photo 7), is then pumped into two roll-off containers (LRVs, Photo 8) where the suspended solids are filtered, and the water is returned to the process. When full, the contents of the LRVs are sent to a Subtitle D landfill. Prior to the installation of the new system, the facility accumulated wastewater in the same four concrete basins, and the water/solids mixture was periodically pumped into a tanker truck and transported to a "perc pond" located approximately one mile from the facility. Mr. Price stated that settled solids were occasionally removed from the pond.

*Shakespeare had used the "perc pond" since the early 1970s. EPA is concerned that there is a possibility that the "perc pond" may have accumulated hazardous constituents prior to the installation of the new wastewater treatment system.*

**Photo 7.** Concrete basins of wastewater treatment system.

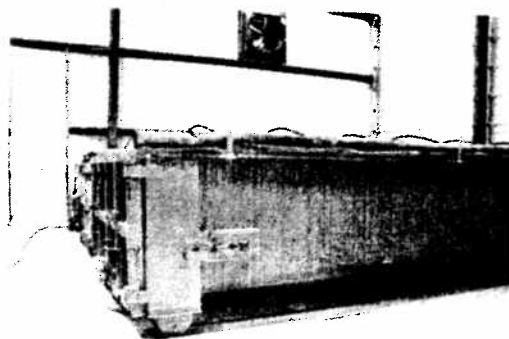
**Photo 8.** LRVs as part of wastewater treatment system.

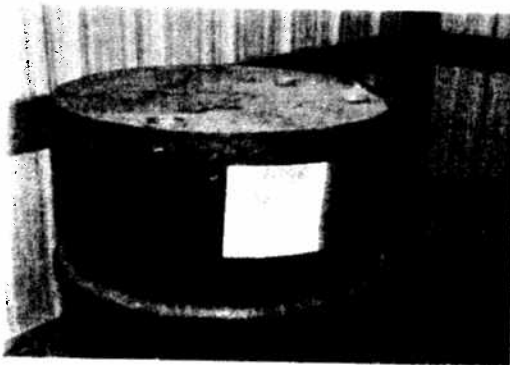
Of the five drums stored on the left side of the building, three were labeled “waste acetone” “D001/F003.” All three containers were properly closed. One drum of “waste acetone” was dated 4/1/2004, but appeared to be an old drum (dust accumulated on the lid, Photo 10). On the reverse side of the drum were hazardous waste labels placed over one another with dates of 11-4-00, 11-19-01, and 11-4-03 (Photo 11).

**Photo 10.** “Old” drum in hazardous waste storage area.

***EPA recommends that Shakespeare ensure containers of hazardous waste are properly labeled with correct accumulation start dates and are not inadvertently re-labeled when they should be shipped off-site.***

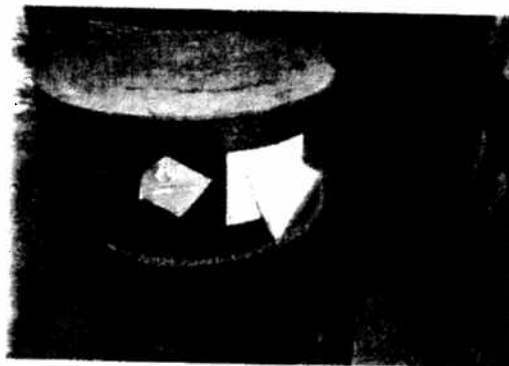
**Photo 11.** Multiple labels on same drum in hazardous waste storage area.

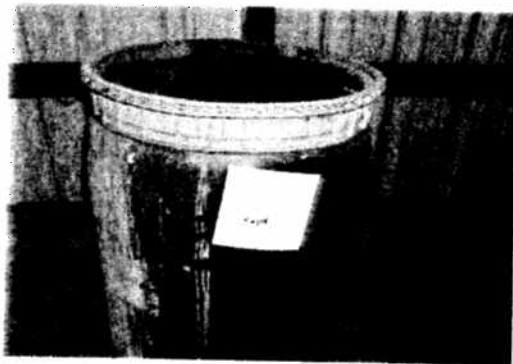
Both drums of the KOH " were properly labeled and were dated "3/6/2004." One of the drums was open and did not appear to have a liquid inside, but rather was a solid material mixed with garbage (Photos 12 & 13). Inspectors asked Mr. Price why the two containers were not transported off-site with the other hazardous waste shipped on the prior day. Mr. Price stated that they had not found anyone to take the material yet, as their current transporter and/or disposal company would not.

By failing to keep a container of hazardous waste closed during storage, Shakespeare has failed to adhere to a condition for exemption from RCRA § 3005 given in SCHWMR R.61-79.265.173(a) [40 CFR § 265.173(a)], as incorporated by SCHWMR R.61-79.262.34(a)(1)(i) [40 CFR § 262.34(a)(1)(i)]. This regulation allows that a generator of hazardous waste may store hazardous wastes on-site, without a permit or interim status, provided that containers holding hazardous waste remain closed except when it is necessary to add or remove waste. As such, Shakespeare is storing hazardous waste in violation of RCRA § 3005.

**Photo 12.** Open drum of "KOH."

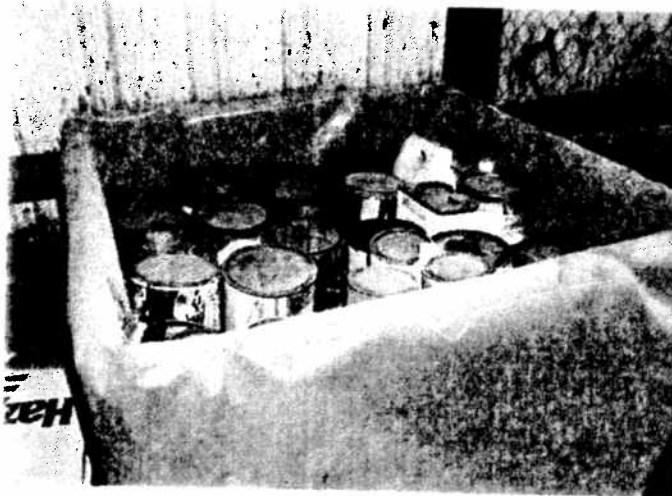
The 1-cubic yard tote stored in this area contained miscellaneous old paint and solvents (Photo 14). Mr. Price stated that they were looking for a disposal company to take the paint. Shakespeare was not treating the paints/solvents in the tote as hazardous waste, although several solvents had ignitability listed as a characteristic on the container labels.

Therefore, Shakespeare failed to make an adequate waste determination on the materials in the tote and failed to properly manage the materials as hazardous waste.

Shakespeare is in violation of SCHWMR R.61-79.262.11 [40 CFR § 262.11]. This regulation requires that a person who generates a solid waste, as defined in SCHWMR R.61-79.261.2 [40 CFR § 261.2], must determine if that waste is a hazardous waste using the methods described in this section.

Shakespeare has failed to adhere to a condition for exemption from RCRA § 3005 given in SCHWMR R.61-79.262.34(a)(3) [40 CFR § 262.34(a)(3)]. This regulation allows that a generator of hazardous waste may store hazardous waste on-site, without a permit or interim status, provided that while being accumulated on-site, each container is labeled or marked clearly with the words "Hazardous Waste."

Shakespeare has failed to adhere to a condition for exemption from RCRA § 3005 given in SCHWMR R.61-79.262.34(a)(2) [40 CFR § 262.34(a)(2)]. This regulation allows that a generator of hazardous waste may store hazardous wastes on-site, without a permit or interim status, provided that each container holding hazardous waste is marked with the date upon which each period of accumulation begins. As such, Shakespeare is storing hazardous waste in violation of RCRA § 3005.

Shakespeare has failed to adhere to a condition for exemption from RCRA § 3005 given in SCHWMR R.61-79.265.173(a) [40 CFR § 265.173(a)], as incorporated by SCHWMR R.61-79.262.34(a)(1)(i) [40 CFR § 262.34(a)(1)(i)]. This regulation allows that a generator of hazardous waste may store hazardous wastes on-site, without a permit or interim status, provided that containers holding hazardous waste remain closed except when it is necessary to add or remove waste. As such, Shakespeare is storing hazardous waste in violation of RCRA § 3005.

Photo 14. Tote of old paint and solvents.
